Contract #: 04-0120F4Cty: SF/ALA Rte: 80 PM: 13.2/13.9File #: 99.28**WELDING INSPECTION REPORT****Resident Engineer:** Casey, William**Address:** 333 Burma Road**City:** Oakland, CA 94607**Report No:** WIR-029653**Date Inspected:** 04-Jun-2013**Project Name:** SAS Superstructure**OSM Arrival Time:** 700**Prime Contractor:** American Bridge/Fluor Enterprises, a JV**OSM Departure Time:** 1530**Contractor:** USA Hoist**Location:** Crest Hill, IL

Component: SAS Tower Elevator

Bridge No: 34-0006**Summary of Items Observed:**

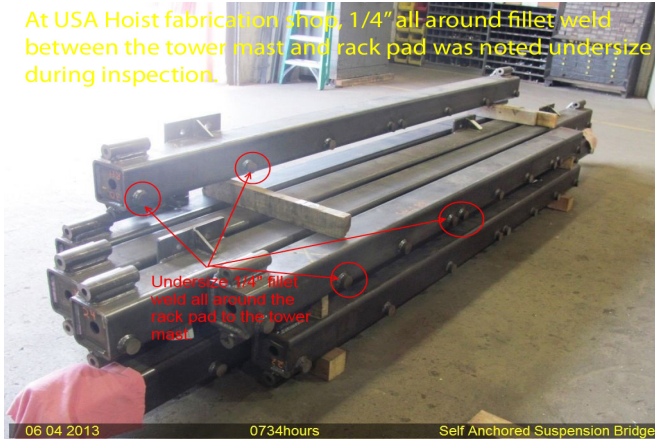
At USA Hoist assembly shop, this QA randomly observed USA Hoist certified welder Matt Wasiqi perform 2F (horizontal) position gas shielded Flux Cored Arc Welding (FCAW-G) welding 1/4" fillet repair between 1 3/4" diameter x 7/8" thick rack pad to 6" x 6" x 3/8" thick tube steel tower mast. This fillet weld repair is being made after this QA had found that they were undersized. Since there was no QC at the shop, this issue was brought to the attention of USA Hoist Project Engineer Robert Overbeek and agreed to the findings of this QA. Mr. Overbeek then instructed the welder to fix the undersized 1/4" all around fillet weld.

At USA Hoist fabrication shop, 1/4" all around fillet weld between the tower mast and rack pad was noted undersize during inspection.
